Beacon's Beach Coastal Bluff Restoration Plan

**City of Encinitas
505 S. Vulcan St.
Encinitas, CA 92024**

November 2020

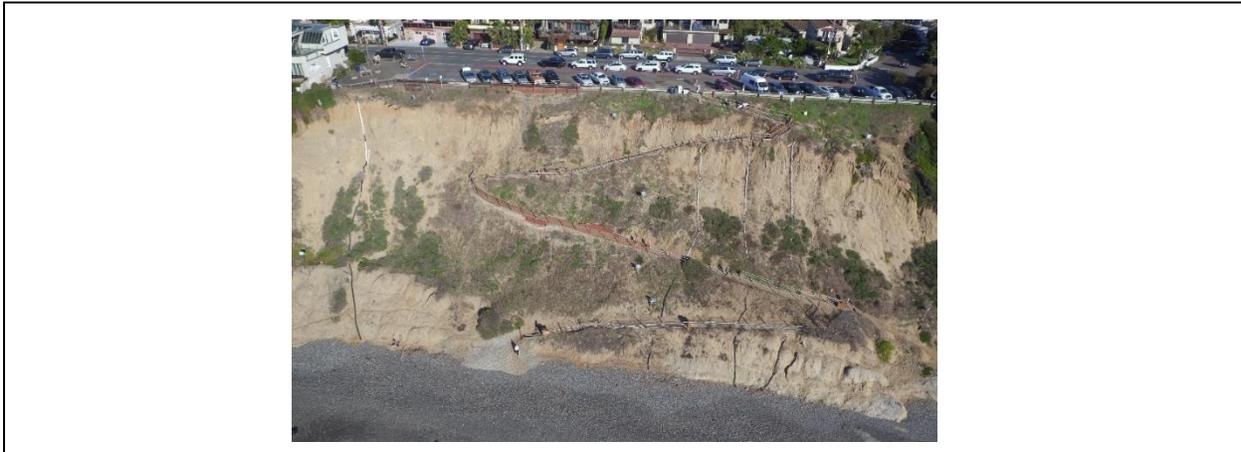
Beacon's Beach Coastal Bluff and Trail (January 2020).

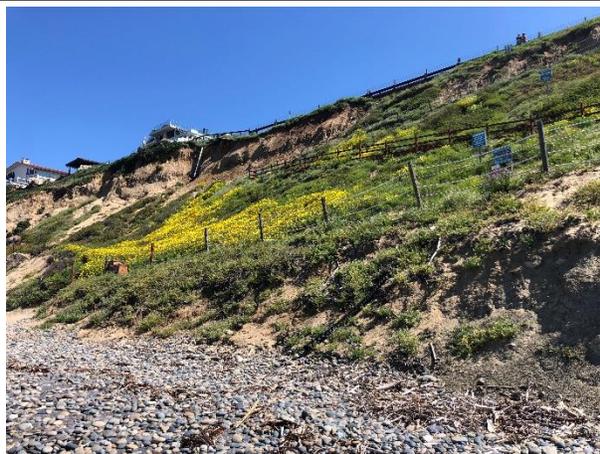
The yellow flowering plants, California sunflower are native and shall remain in place and be avoided during restoration activities (April 2020).

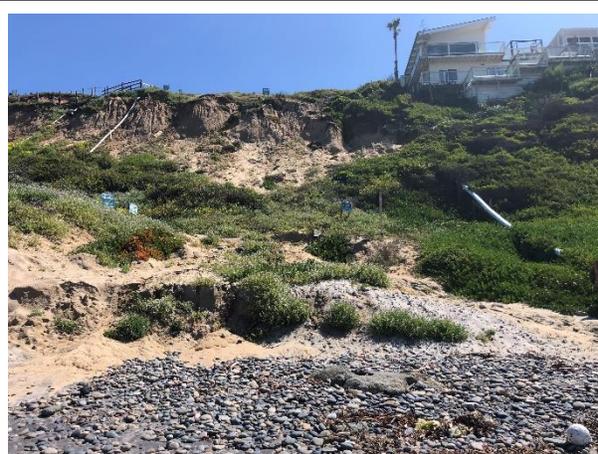
Plantable and potential dune location, south end of Beacon's Trail (April 2020)

As a pilot project, the City of Encinitas is interested in supporting natural dune development at the toe of the Beacon’s Beach bluff that would utilize this washed up kelp. Washed up kelp would be periodically brought up to the toe of the slope of the bluff and then allowed to naturally decompose. The pile of wracked kelp would assist in the natural development of a dune by suspending sand and stabilizing cobble. Kelp wrack piles enhance the formation of hummocks and larger dunes by catching and holding windblown sand (Dugan 2011). Kelp wracks have assisted in the development of larger hummocks at the Cardiff State Beach Living Shoreline Program (2019). The City is interested in the development of a small, naturally forming sand dune at the toe of slope of Beacon’s Beach to enhance the stability of the toe of slope, limit the wave run-up on the trail and trail toe, and potentially steer beach goers away from being up against the naturally eroding bluffs. Though the dunes would not be planted or seeded, native plants that will be planted through the Beacon’s Bluff Restoration Program are expected to naturally recruit into these dune areas.
